SERVICE MANUAL

MODELS:	TD-145	Series I
	TD-160	Series I
	TD-165	Series I
	TD-145	MKII Isotrack
	TD-160	MKII Isotrack
	TD-166	MKII Isotrack

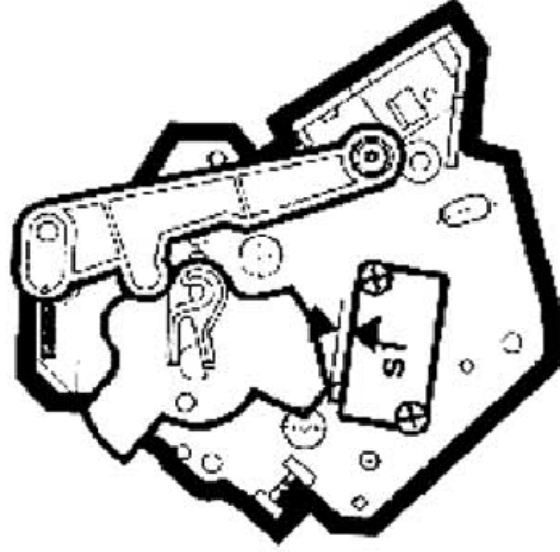
SERVICE ADJUSTMENTS

Switch adjustments; If it becomes necessary to adjust the switches, there is a defined value of clearance associated with each function switch.

Remove the hardboard bottom cover. The micro switch S-1 associated with the speed selection control must have a clearance of 0.8mm between the actuating arm and the body of the switch when the speed selection control is in the "STOP" position.
